## QUALITY AUDIT REPORT — YACHTING

Report YCH-2026-0032

# M/Y Blue Horizon

14 June 2026 · 08:15 – 10:45

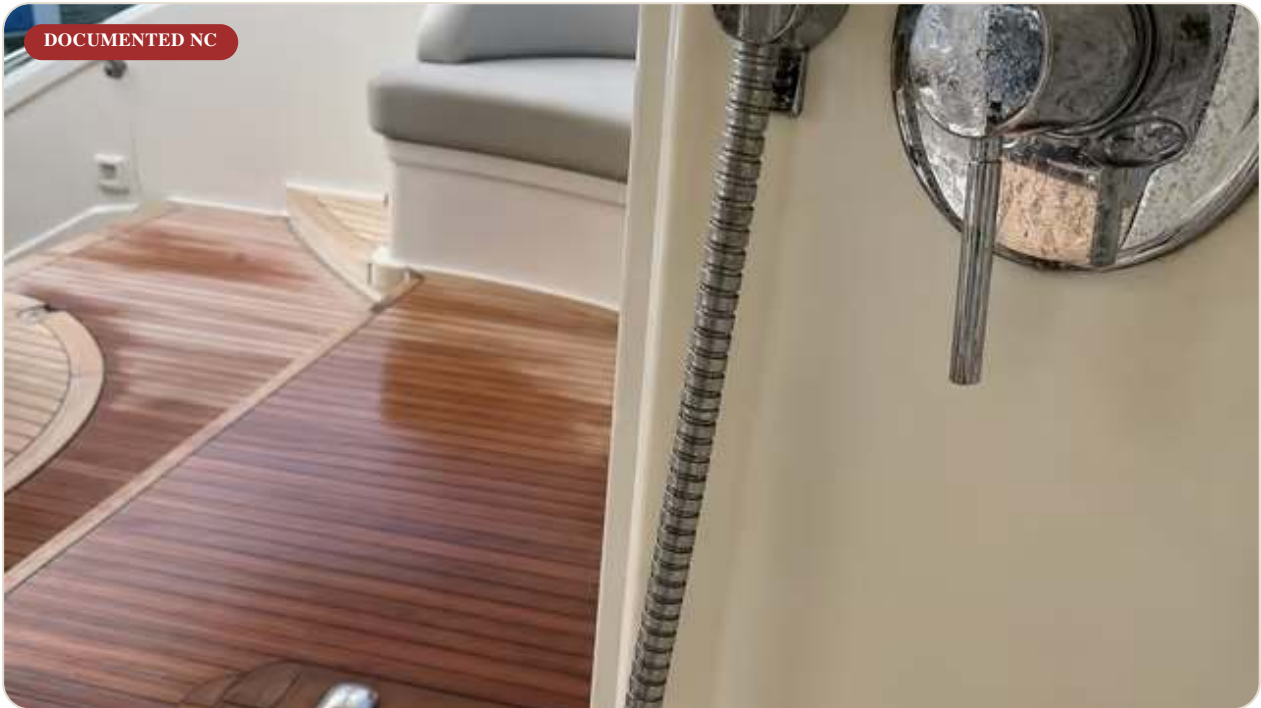
Beach club — Deck shower

Signature zone of the superyacht and first visual contact from the quay — this is the zone pulling the exterior score down. Two findings: a scaled deck shower (dense white limescale deposit on the taps and the floor) and blackened teak seams over roughly 30% of the surface. The blackening points to a maintenance shortfall spread over 2 to 3 rotations, not a failure of this turnaround alone. Descaling and reviving the seams are the priorities: the zone remains eliminatory for the Label as long as it stays below 80%.

Dense white limescale deposit over the whole of the deck-shower taps and on the floor tiling within a 40 cm radius. Immediately visible from the quay on approach — signature zone of the beach club, the first zone seen by the guests at boarding. Maximum image impact.

Clause 3.2 — The vessel must be delivered clean and in good working order. A deposit visible to the naked eye constitutes a documented non-conformity, reportable to the owner.

| ASSIGNED TO | DEADLINE | EQUIPMENT |
|---|---|---|
| Deck Crew + contractor | Before 11:00 | Professional descaler (Stardrops Marine Descaler), seam brush, fresh-water rinse |

Descalc the beach club shower (taps + floor)  
Deck Crew + contractor · Marine descaler

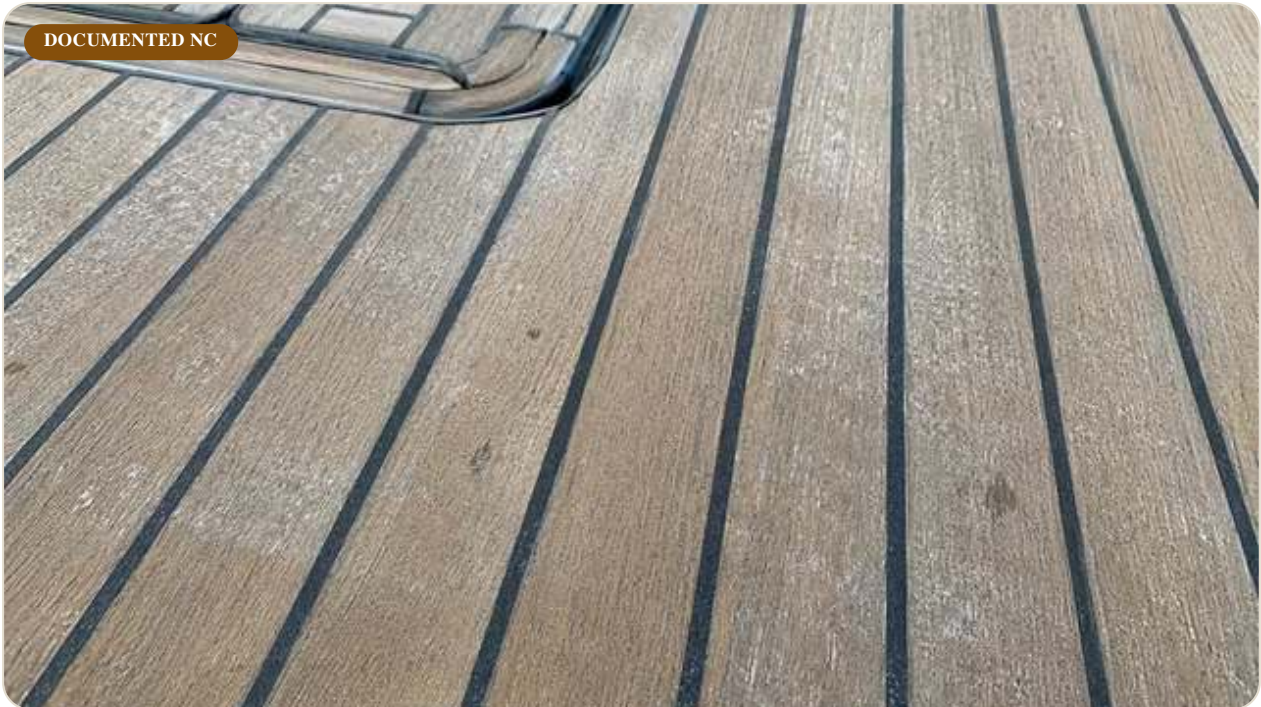
Beach club — Teak seams

Seams between the teak planks blackened over roughly 30% of the beach club surface. The blackening is the sign of a maintenance shortfall over 2 to 3 rotations — not a failure of this turnaround alone. Immediately visible from the quay: signature zone of the superyacht, first visual contact with the water.

Clause 3 — Delivery standard “clean and in good order”. The state of upkeep of the most exposed zone shapes the perception of the charter from the approach.

| ASSIGNED TO | DEADLINE | EQUIPMENT |
|---|---|---|
| Deck Crew | Before 12:00 | Soft seam brush, teak brightener, fresh-water rinse |

Brush and revive the beach club teak seams  
Deck Crew · Seam brush + teak brightener

The beach club needs a quarterly treatment of the seams with teak brightener. The current blackening calls for a thorough intervention before mid-season (July). Estimated budget: 3 to 4 hours of contractor labour.

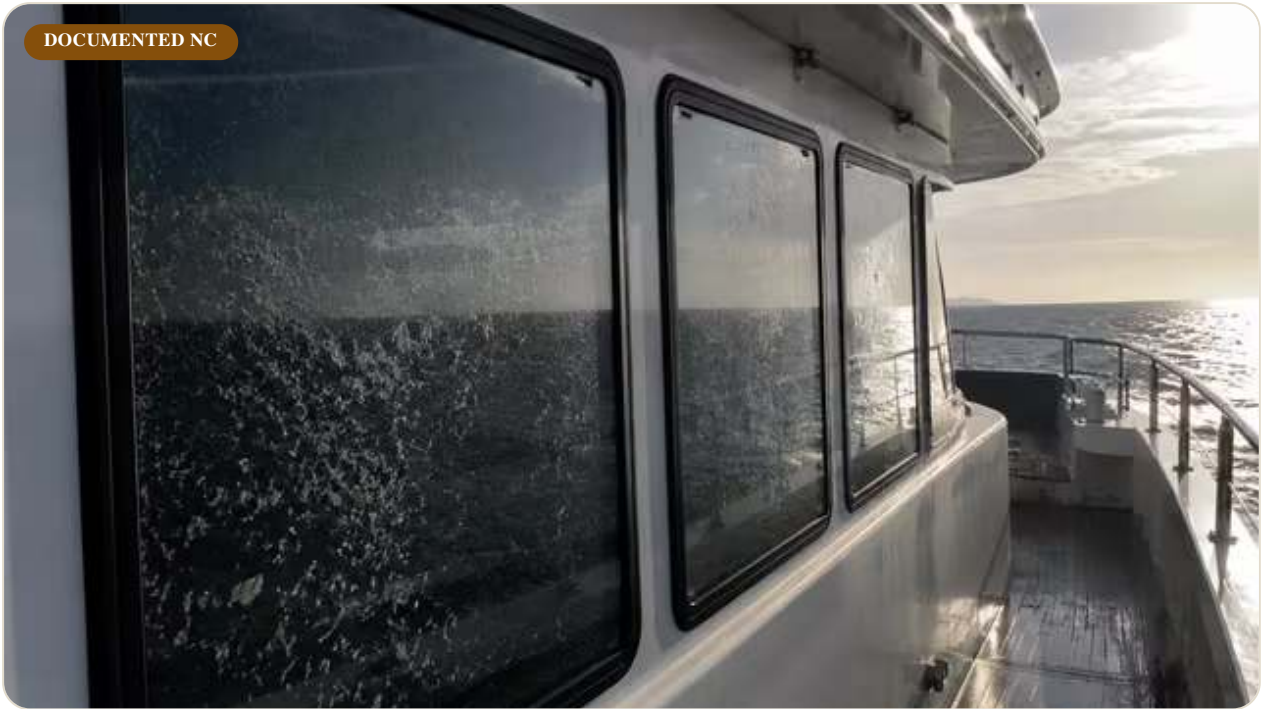
Port deck — Windows

The walkway teak is clean, brushed with the grain, with no grey patches. The non-conformity is concentrated on three glass panels on the port side, marked with crystallised salt — a direct consequence of the SW wind of the last 48 hours, which carries spray onto this side. A fresh-water rinse and a microfibre wipe are enough: 20 minutes of deck crew. The rest of the deck is at standard.

Crystallised salt on 3 glass panels on the port side, main deck. Consistent with the conditions of the last 48 hours (SW wind carrying spray). Simple correction: fresh-water rinse + microfibre wipe. Estimated time: 20 min of deck crew.

Clause 3 — Glazed surfaces in the direct line of sight from the cockpit. Minor non-conformity, documented and correctable before boarding.

ASSIGNED TO  
Deck Crew

DEADLINE  
Before 11:00

EQUIPMENT  
Fresh water + marine microfibre

Rinse the port-side windows (3 panels)  
Deck Crew · Fresh water + marine microfibre

Set up a systematic rinse after any episode of SW wind above 15 knots (onshore spray). Duration: 45 min of deck crew. Prevents the build-up of crystallised salt on the glazed surfaces.
