## QUALITY AUDIT REPORT — YACHTING

Report YCH-2026-0032

# M/Y Blue Horizon

14 June 2026 · 08:15 – 10:45

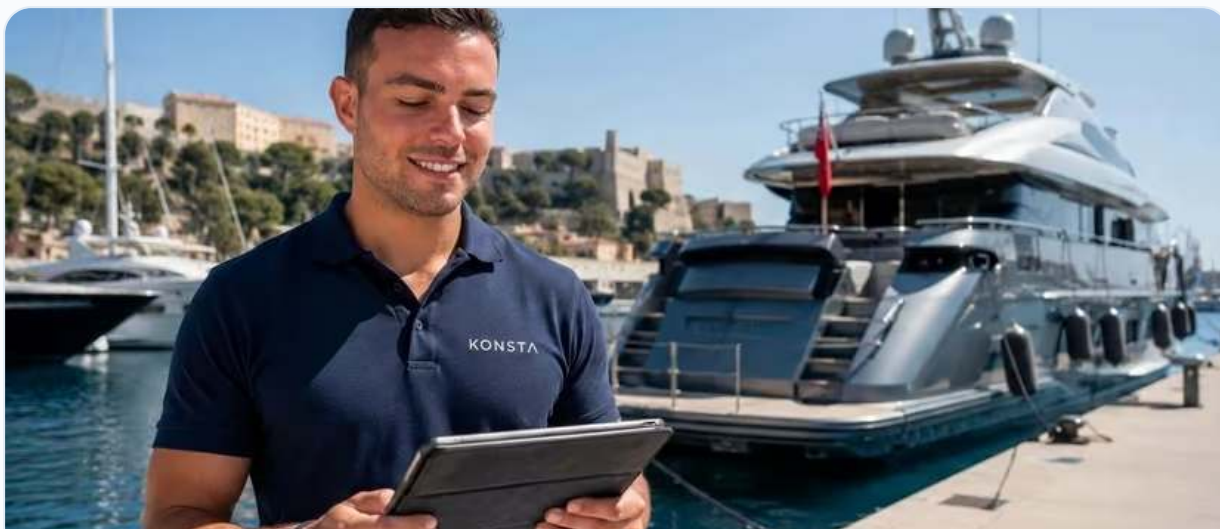
*08:15 · Port Vauban, Antibes — first visual contact from the quay, start of the audit.*

At the time of the audit (08:15, i.e. 6 h 45 min before boarding), the exterior condition of the yacht (85%) is below the Konsta Superyacht threshold (90%). Three non-conformities documented by time-stamped EXIF photos concern the beach club and the main deck.
